Cathedral of the Blessed Sacrament - November 2011 Update

INTRODUCTION

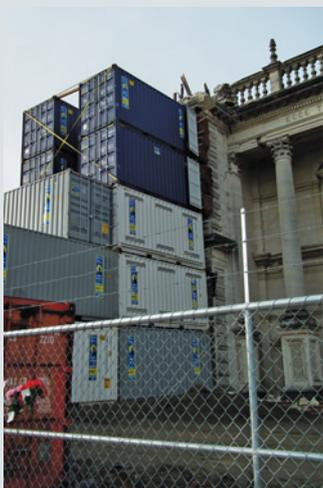
By Christmas the North Bell Tower should be down.

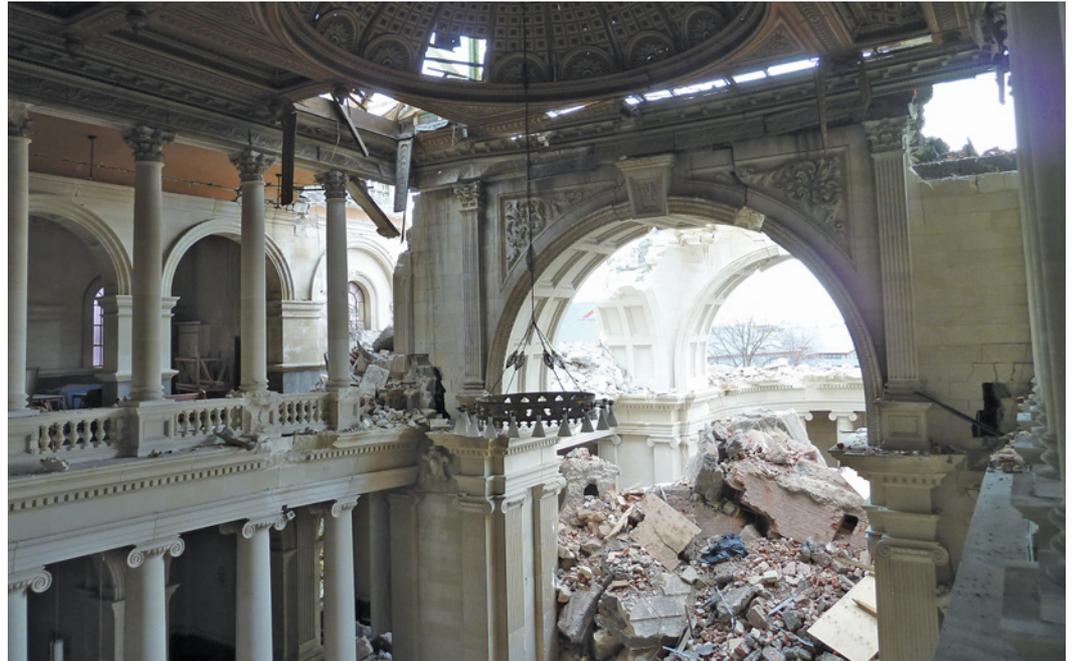
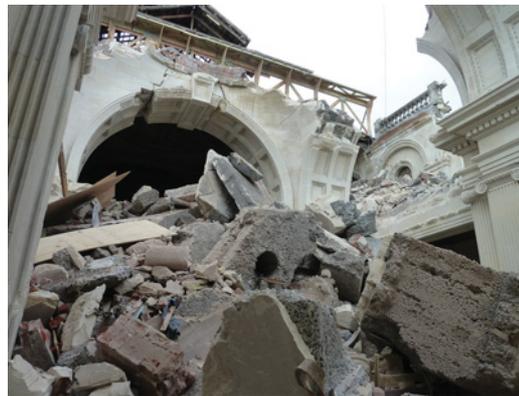
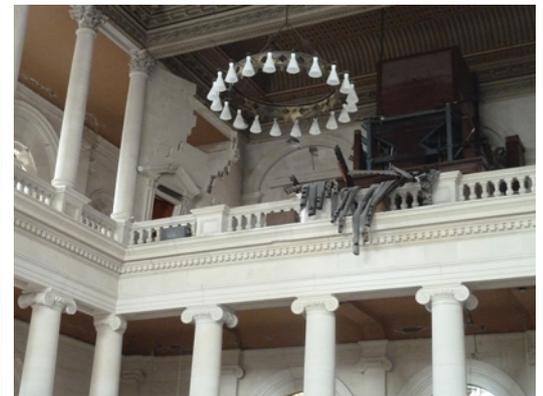
Sanctuary and Sacristy

- >> The rear of the building is moderately to seriously damaged.
- >> The engineers report there has been significant settlement of the arches with a noticeable difference in level between the external walls and four pillars. The four pillars, while cracked and damaged, appear to be reasonably undamaged through their core and remain capable of supporting the floor above. However, given the extent of settlement, repair is not considered feasible. Likewise, repair of the arches is not considered feasible.

- >> The internal sacristy walls are moderately damaged and displaced out-of-plane, which would make repair of this section of the walls difficult and costly.

- >> The external east wall is moderately damaged, the south wall has severe to moderate damage, and the north wall has had some minor damage.
- >> The first floor seems relatively intact and is believed to be not in risk of collapsing.

- >> Further investigation will be conducted to provide conclusive engineering and heritage assessments on these two areas.
